FIELD TESTS TO STUDY THE PRESSURE
VARIATION INDUCED BY WAVE ACTION ON THE
MITER GATE LEAVES OF THE BUCKET CAISSON
DRYDOCK AT GRAND COULEE DAM--
COLUMBIA BASIN PROJECT

Hydraulic Laboratory Report No. Hyd.-282

JULY 6, 1950

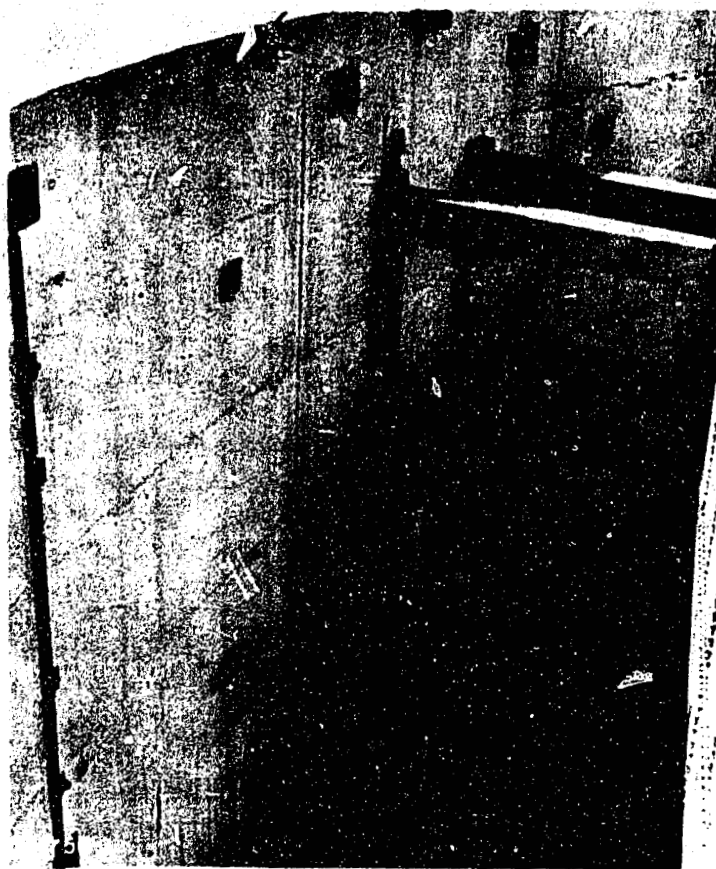
A. TIMBER WEDGE STRUTS BETWEEN TIPPING SECTION AND MITER GATE LEAVES.

cables holding the gate leaves could have broken with a static unbalanced pressure of 4.5 feet of water, but that failure was probably caused by a dynamic rather than a static condition; (2) failure of the anchor bars holding the hinge of the No. 2 leaf at the top of the miter gate was probably caused by bending moments induced by the water forces moving the gate against the friction of the gudgeon pin and hinge; and (3) the rivets in the gate loosened because of a torsional deflection of the leaves during the swinging motion. The memorandum and report recommended that information concerning the wave pressures on the miter gate be obtained before the design of a permanent device to hold the gate shut was completed and that the gate be wedged shut by timber struts placed between the gate and tipping section for the 1947 flood season. The wedges used during the 1947 season when pressure-cell measurements were made are shown on Figure 3A. No trouble was experienced with this arrangement.

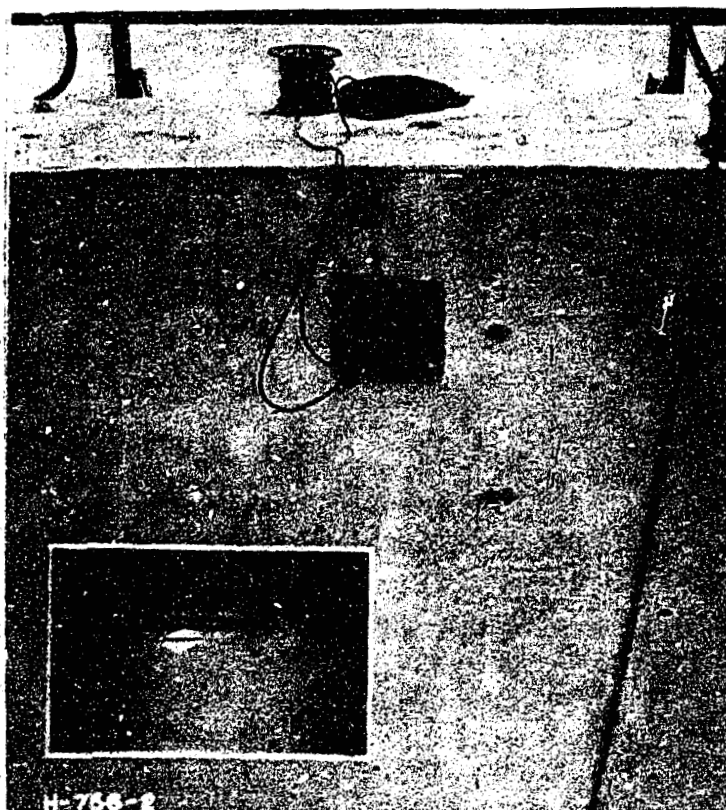
B. PRESSURE CELL INSTALLATION
IN TIPPING SECTION.

the drydock. Pairs of these cells were mounted in the concrete tipping section by drilling a hole through it and inserting a short section of 3-inch pipe containing a cell at each end. The pressure ends of the cells were flush with the surfaces of the tipping section (Figures 3B and 4B). The pressure-cells on the miter gate were located in a similar position, three on the outside and three on the inside, but were mounted as shown in Figures 4B and 5. Seven cells were mounted on the No. 4 access shaft of the caisson to record pressures on the inside and outside of this shaft. Three were placed at elevation 955 and three at elevation 970. The cells of each group were set 120° apart (Figure 4B). The seventh cell was placed on the inside of this shaft at elevation 955. The cells were designated by numbers, 1 to 6 on the tipping section, 7 to 12 on the miter gate, and 13 to 19 on the access shaft.

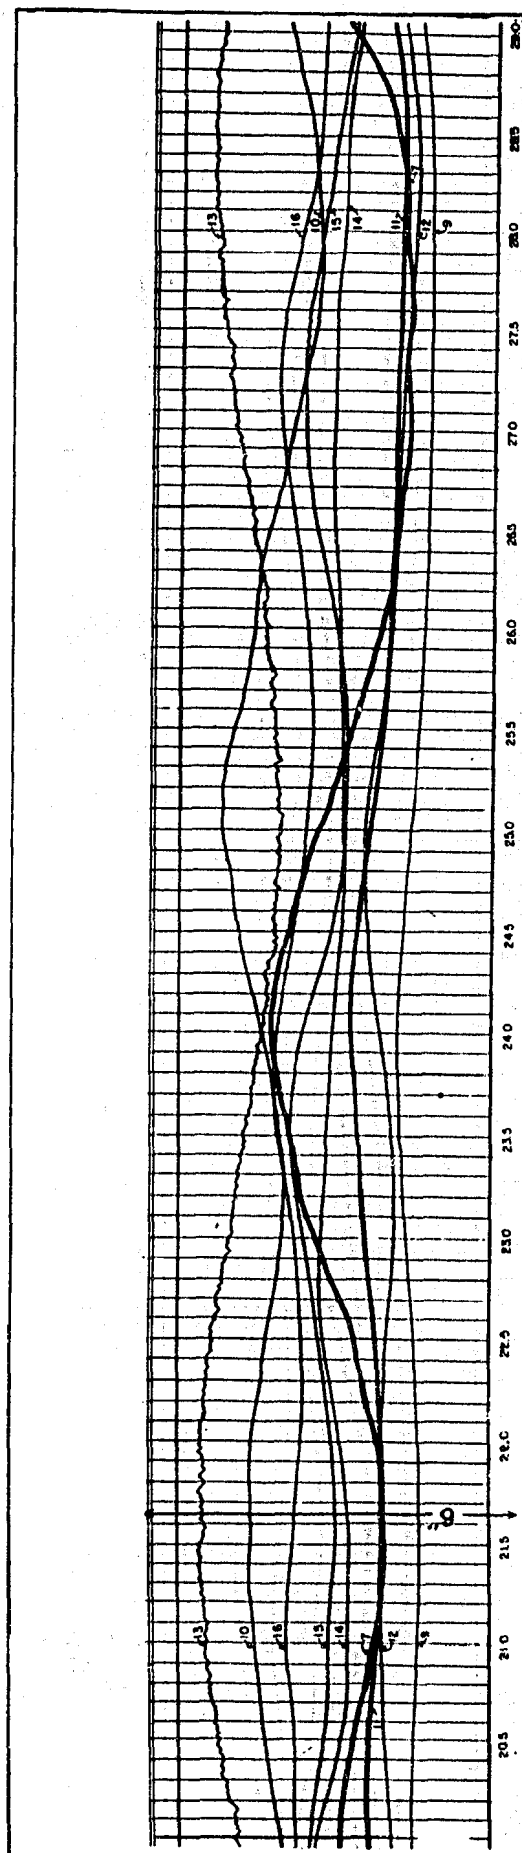
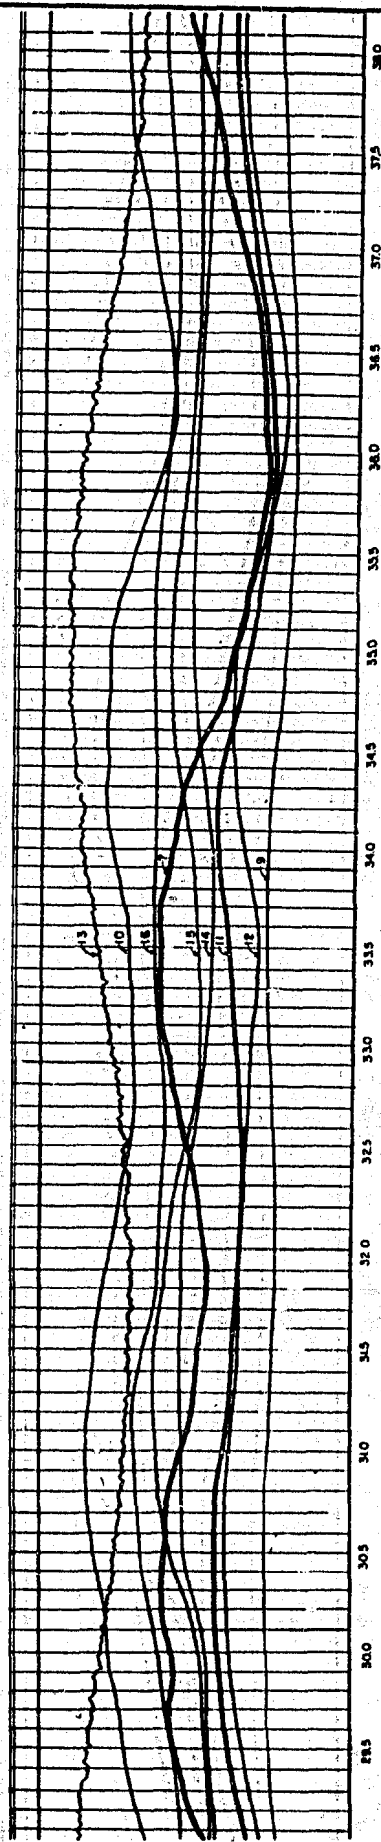
GRAND COULEE DAM
WAVE STUDIES
OSCILLOGRAPH RECORD
TEST NO. 10

The oscillograph records obtained during the test showed the variation of pressure at the cells due to wave action over the drydock and on the caisson (Figure 6). These records were obtained with the paper moving at approximately 3 inches per second and with the time scale being marked by a line every 1/10 second. Each test lasted from 1 to 2 minutes; thus the records were between 15 and 30 feet long. The pressure variation of the cells formed a wavelike pattern on the sensitized paper, the amplitude of which was controlled by changing resistances in the oscillograph. The amplitude of the traces was adjusted to about 1 inch to facilitate placing simultaneous records of several pressure-cells on a single sheet of oscillograph paper. Each trace was then on a different relative scale, and it was necessary to transform the data to a common pressure scale to compare and evaluate the data.

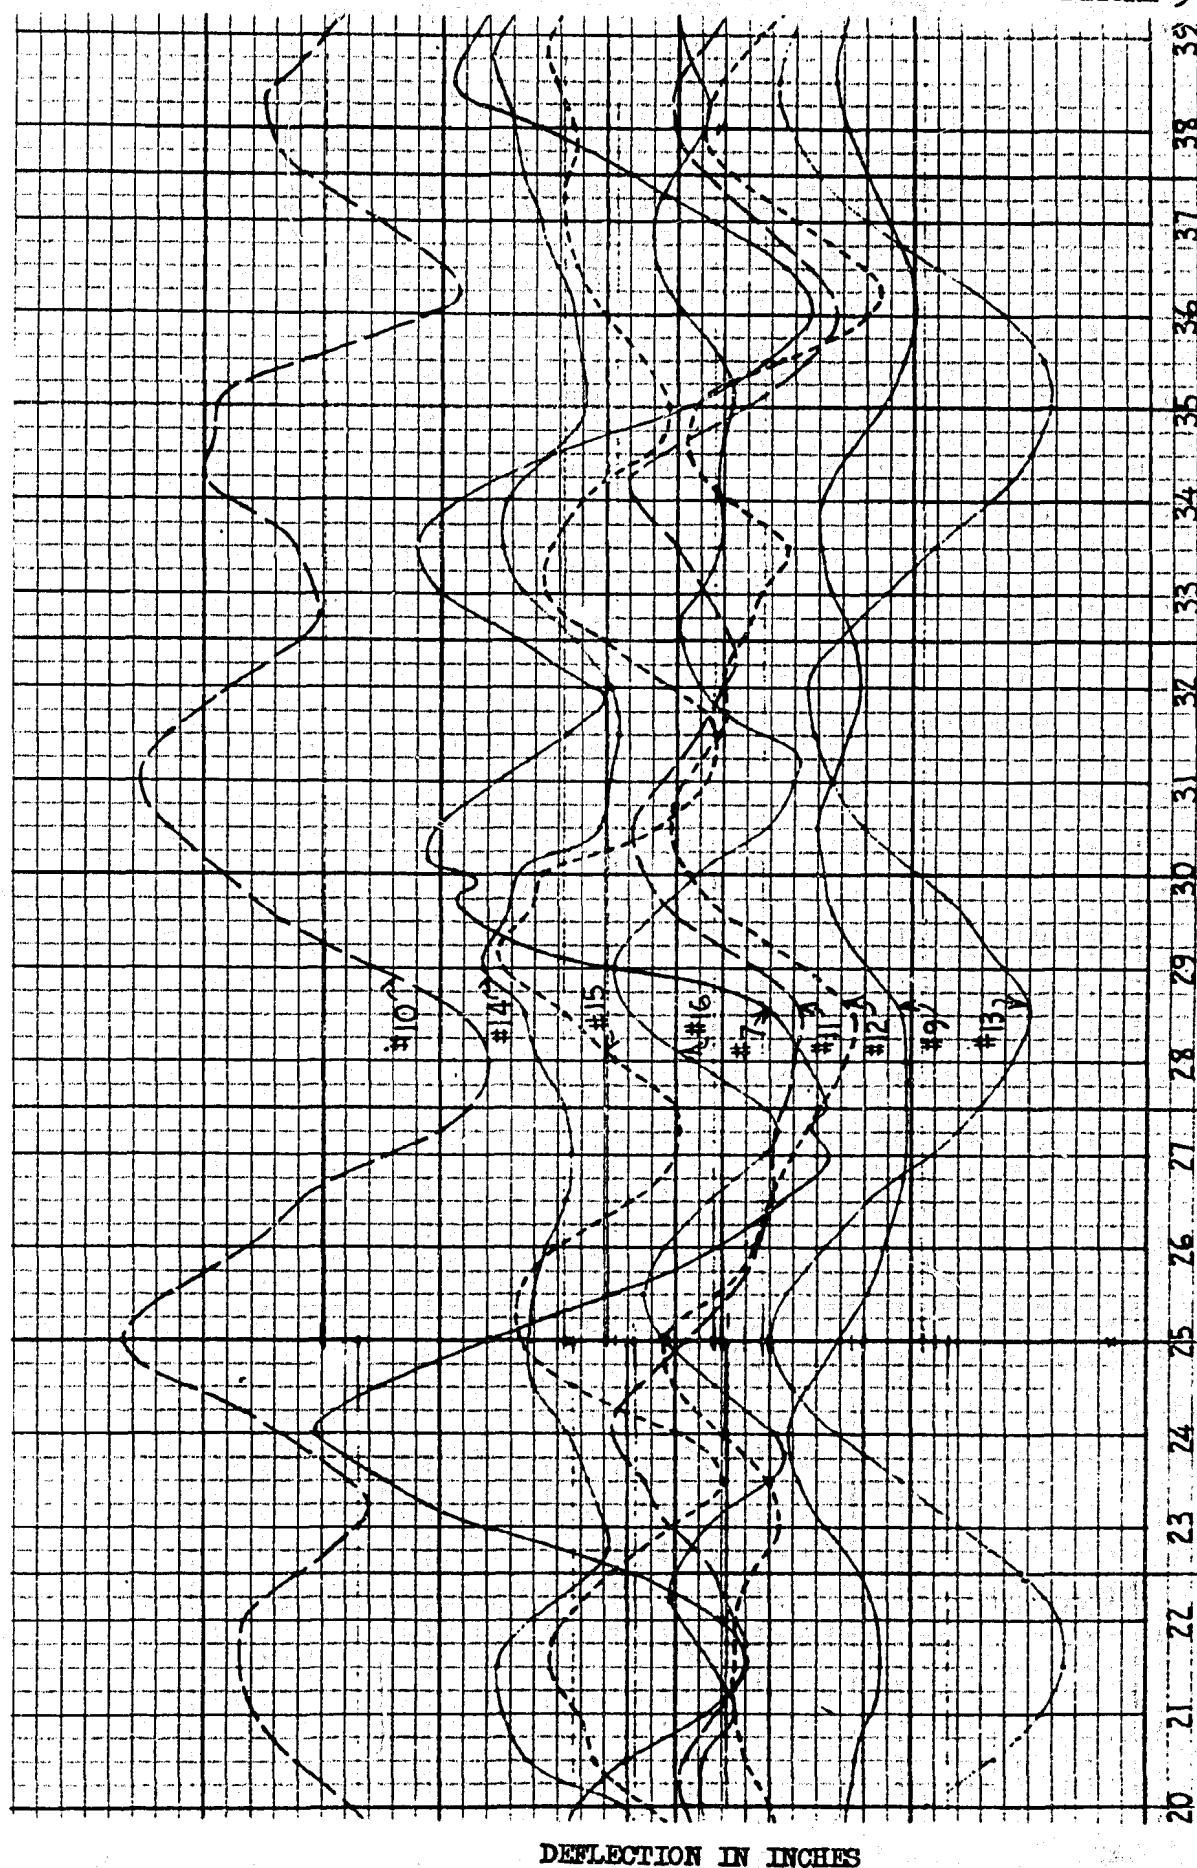
TIME IN SECONDS
PRESSURE TRACES TRANSFERRED FROM OSCILLOGRAPH RECORD TEST 10

The irregular variation of pressure with respect to time at the several cells (Figure 9) was attributed to wave action since waves were described as being of a choppy irregular nature. It was noted that the amplitude of the pressure variations for a single cell was about 1 foot of water at the smaller discharges and about 1-1/2 feet of water at the larger discharges. The wave heights (from crest to trough) for the corresponding discharges as indicated by the suspended pile driver weight, about 30 feet away from the drydock, were about 1.7 feet for the smaller discharges and about 3.3 feet for the larger discharges; thus, the pressure variations as shown by the cells do not indicate the full height of the waves. A further study of pressure variation with respect to depth was made by comparison of records from the cell groups 1 and 5; 7, 9, and 11; and 10 and 12; but no consistent variation with depth was found.

The curves of Figure 9 show not only the magnitude of the varying pressure acting upon the cells, but also the phase differences between the cells on the different sides of the tipping section and the miter gate. These phase differences show how the pressures on the miter gate become unbalanced. At a given instant the pressure may be of a certain magnitude on the inside of the gate while it may be greater or less on the outside of the gate. In a study of these curves it was noted that two distinct types of wave action occurred, depending upon the depth of water over the drydock tipping section. When this depth was less than 2.5 feet (Tests No. 4 to 10), the waves apparently broke over the tipping section and miter gate in such a manner that the pressure variations on the opposite sides were very irregular. This was especially true of pressure variations of small magnitude, whereas the larger pressure variations, evidently caused by larger waves, retained their identity as the waves passed over the tipping section and gate. With this type of action, the maximum pressure difference was found to be about 1 foot of water. At the larger discharges and with greater depths over the gate (Tests No. 12 and 16) the wave patterns appeared to be more regular, especially at the peak discharge of 334,000 second-feet (Test No. 16). At this discharge the magnitude of the pressure variation increased to nearly 2 feet of water; however, the phase relationship of the variations at cells on each side of the gate was such that the maximum pressure difference on the gate was approximately 0.87 foot of water, less than that observed at smaller discharges. The manner in which these pressure variations occurred, with a somewhat regular phase difference, suggested that the unbalanced pressures on the opposite sides of the gate could be related to the slope of the waves, and that the assumptions using the Navy results to estimate the pressure differences was applicable, although conservative. In the light of these data, it was concluded that the design value of 2 feet of water for the unbalanced pressure would not be exceeded even with discharges in excess of those at which the tests were made.
